(BDIZ EDI) Implant-Study 2014/2015

Quantitative and qualitative element-analysis of implant-surfaces by SEM and EDX

PRELIMINARY STUDY REPORT

Konus K3Pro "Rapid" SN 613768-1

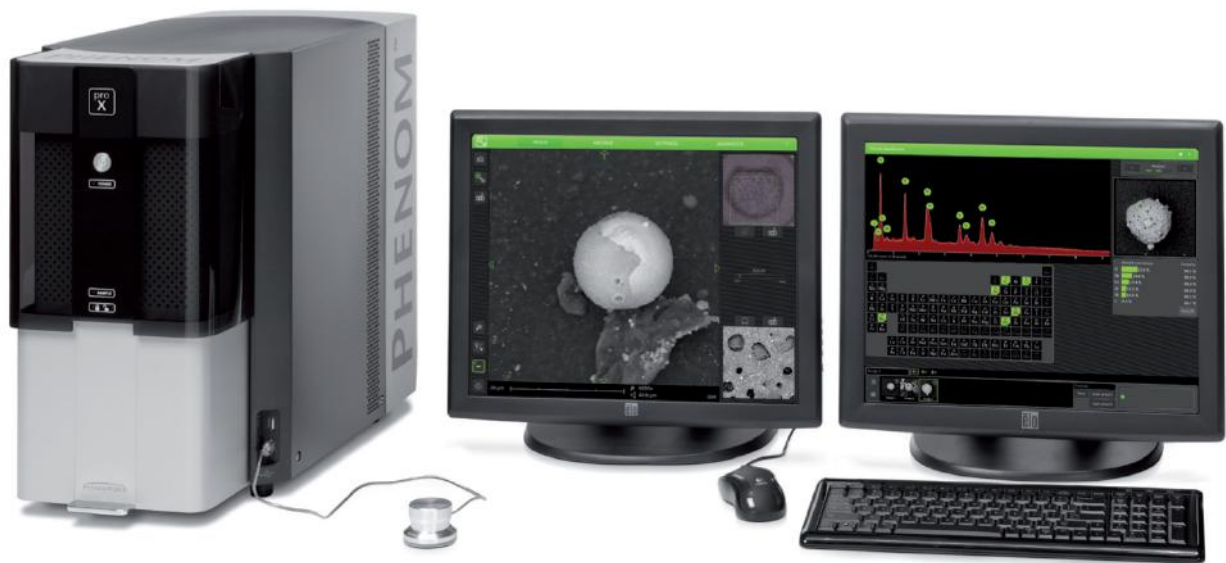
The scientific workstation is a Phenom proX Scanning Electron Microscope, equipped with a high-sensitivity backscattered electron detector that allows compositional and topographical imaging modes. EDX analyses are performed with a thermoelectrically cooled Silicon Drift Detector (SDD).

Workstation with Phenom proX Scanning Electron Microscope
